INSTALLATION RESTORATION PROGRAM ·

PHASE I. - RECORDS SEARCH

HOMESTEAD AFB, FLORIDA

AUGUST 1983

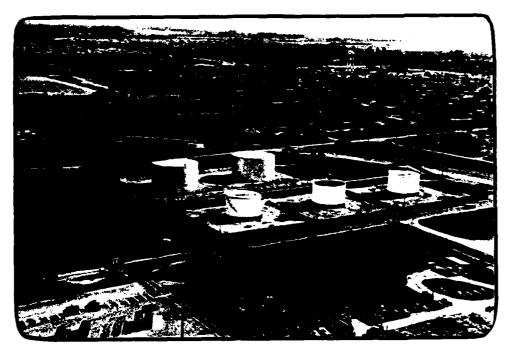
POL Storage Area

2) The leak at the POL Bulk Storage Tank Farm (Figure 6.2) (SP-4) has a moderate potential for environmental contamination and monitoring of this site is recommended. A ground-water monitoring system should be established to characterize the ground-water quality and identify any contaminant migration. One upgradient and three downgradient monitoring wells should be installed. The wells should be constructed of Schedule 40 PVC, screened into the top of the water table (about 10 feet deep). Samples collected from these wells should be analyzed for the parameters in Table 6.2, List A.
